Installation of Sentek Soil Moisture Sensors

Client: Nolan Consulting

Location: Point Wilson, Victoria

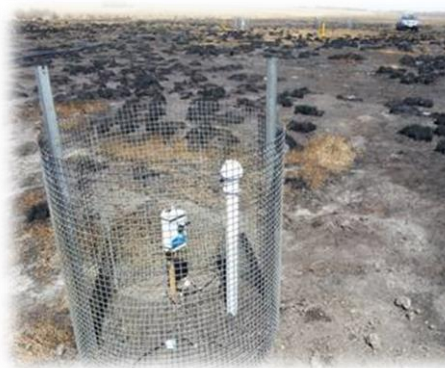
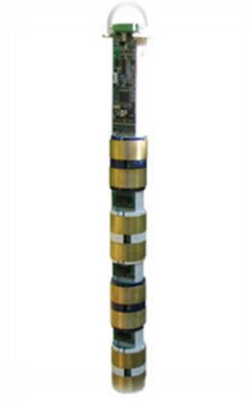
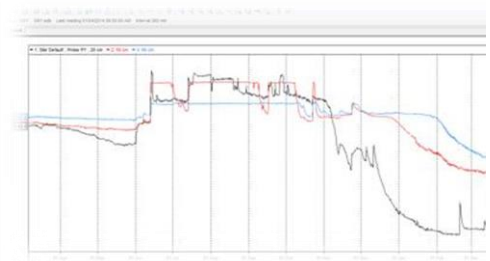
- HydroTerra staff visited the project site to assess damage and re-install soil moisture probes
- Assessment of site included testing the system, inspecting wires and checking for valid readings with probes in place
- Probes were inspected for the presence of gas gaps from the installation process or as a consequence of clay shrinking from the access tube (when necessary the top 15cm of soil was removed and replaced with a non-cracking loam).
- A rubber collar was fitted around the base of the probes to help reduce the instance of cracking and water running down the side of the access tubes.
